NEW ROCHELLE PUBLIC LIBRARY PHYSICAL CONDITIONS ASSESSMENT VOLUME ONE – TECHNICAL REPORT

**MAIN BRANCH
HUGUENOT CHILDREN'S LIBRARY**

2020-02-28

19-058

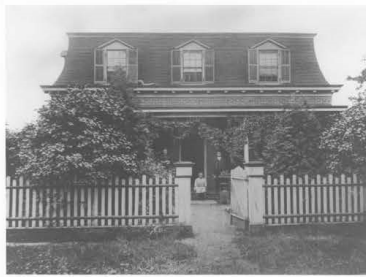
Mahlstedt Residence

The Huguenot Children's Library occupies what was originally the Mahlstedt Residence, constructed about 1870, in a simple Second Empire style. This included a cornice with built-in gutter, slate mansard, and low-sloped upper roof; a veranda extended across the front elevation.

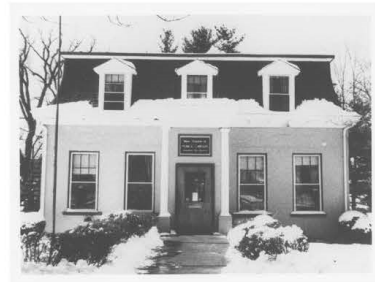
Branch Library

The residence was converted to a branch library in the 1920's. During this renovation, the veranda was removed, and a portico (with Greek columns) was added over the front entrance; at an unknown later date a vestibule was constructed below the portico to enclose the front door.

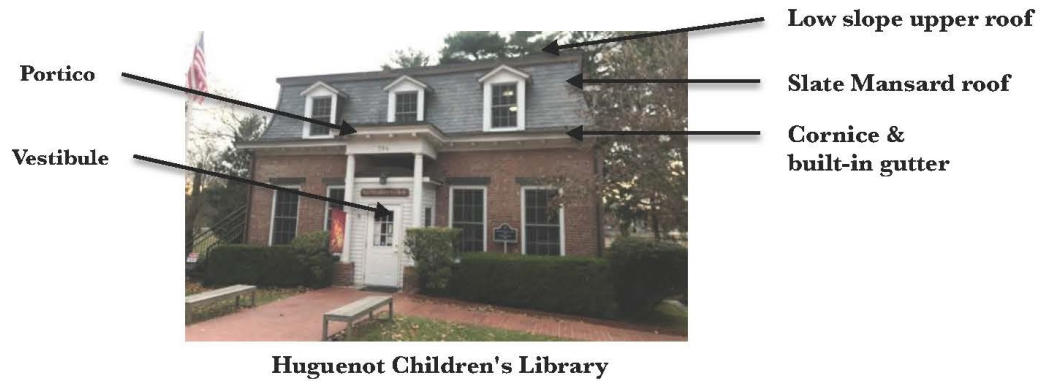
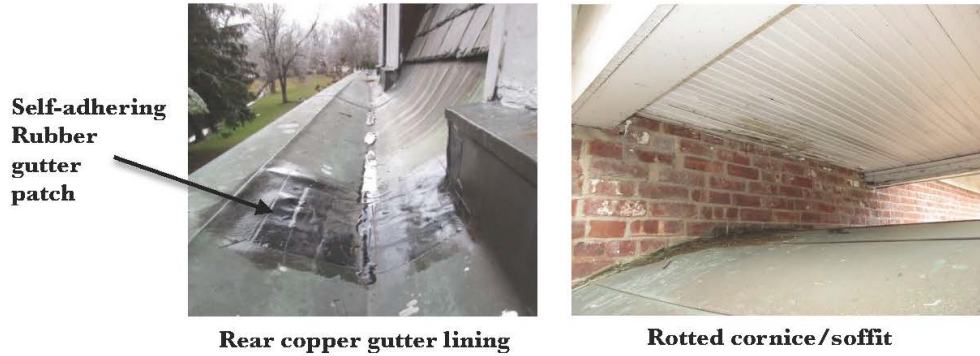
The cornice and built-in gutter surround the entire building. The rear (west) portion of cornice required major carpentry repairs during this past year. This was the result of leaks through the copper gutter lining, which caused the underlying wood to rot. The repairs were conducted without removal of the copper lining, so the extent of the repair work was limited. Leaks were found in other portions of the cornice, and were patched temporarily with self-adhering rubber. The copper lining is not old enough to be worn out; the leaks appear to be due, in part, to fatigue of the metal caused by thermal movement, and subsequent failure of the soldered seams. This would be the expected result for a copper lining that was installed without any expansion joints, which is what we observed. There is evidence of rotted wood in other portions of the cornice.

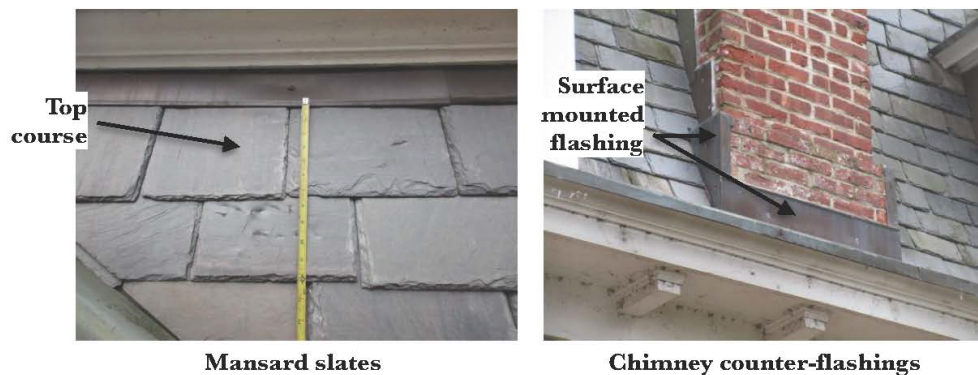
The slate mansard consists of 12" long slates in random widths. The slates are gray, in standard

thickness (1/4") quarried in Vermont. They are fastened with copper nails. There is no cant under the starter course of slate; this prevents the first course of slate from being properly
